Grove Terrace

Application

- Dubuque, IA
- Fall 2008
- Geofom Retaining Wall Stabilization Fill
- 250 Cubic Yards

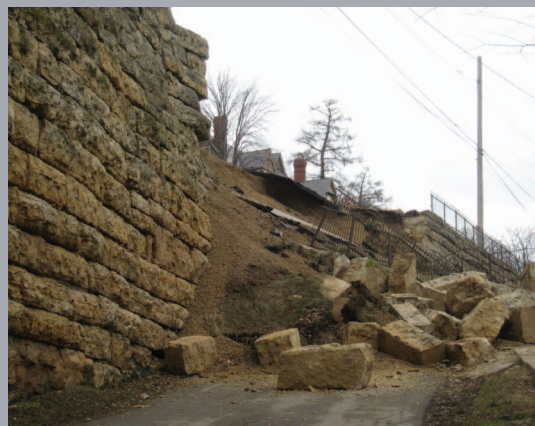
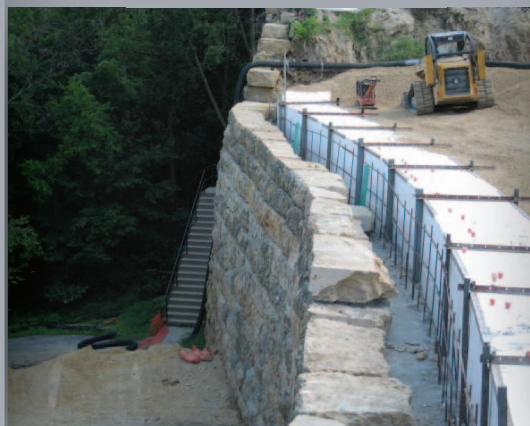
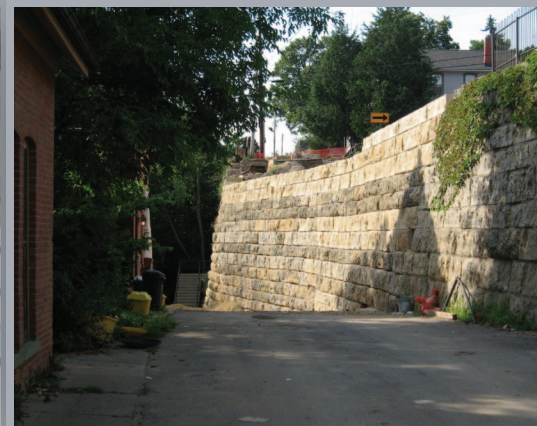
250 cubic yards of EPS 15 Geofom was used as retaining wall stabilization fill along Grove Terrace road in Dubuque, Iowa.

The limestone blocks were restored and used in the construction of the new retaining wall. This was the first time the design team had worked with Geofom. As a result of the project's success, two other retaining walls have been fixed using Geofom as the retaining wall's stabilization fill.

Spring 2008, heavy rains caused the retaining wall along Grove Terrace road to collapse, resulting in limestone blocks tumbling into the roadway below, prompting the closure of West 11th Street. Engineers selected Geofom for its high compressive strength and because it had already been used in newly constructed areas of West 11th Street.
